VCR AUTO-TRACK FIX KIT Z94-16

TOPIC: Unable to auto-track / video break-up on some pre-recorded tapes with J2 and L Line VCRs.

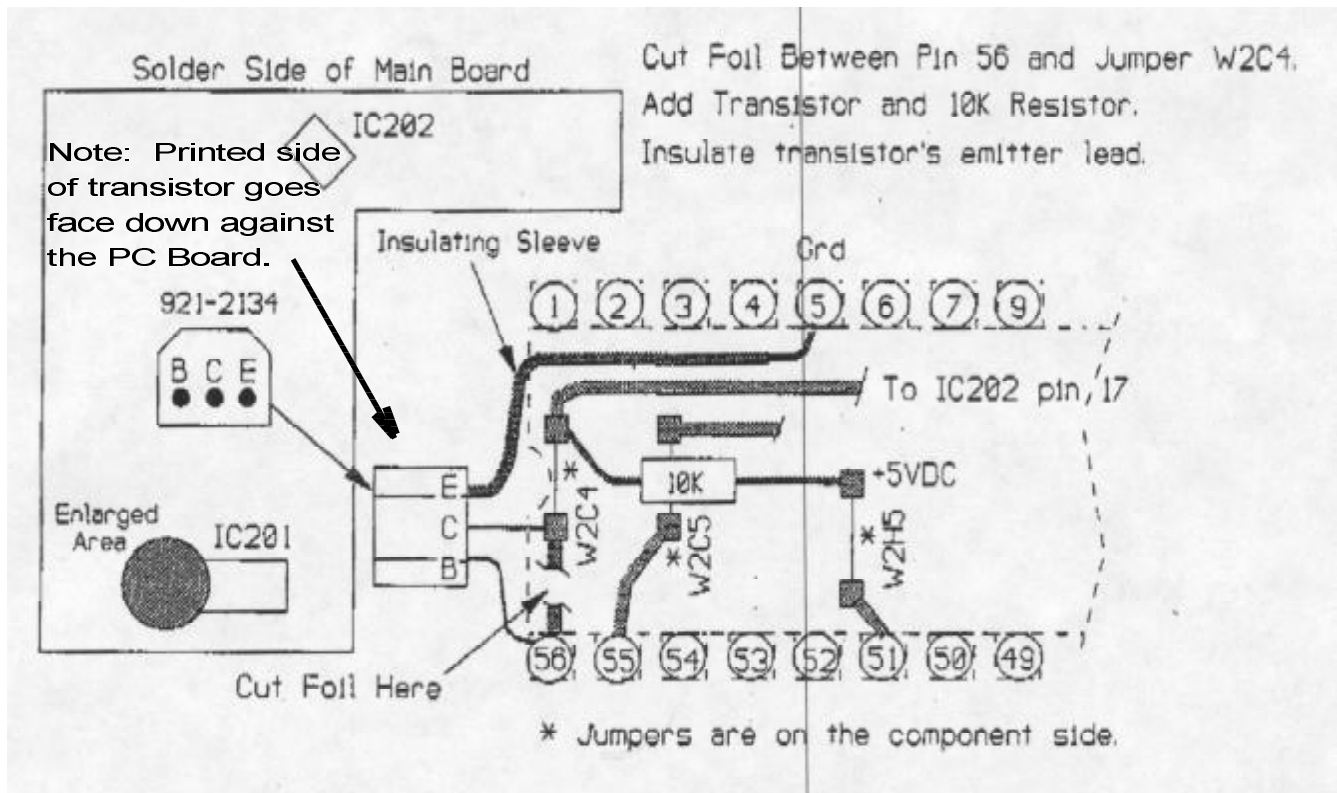
The problem can be corrected by the installation of a transistor and resistor on the foil side of the PCB between IC201 and IC202. The transistor is to be mounted near the pin 56 end of IC201. Cut foil between IC201 pin 56 and the W2C4 jumper pad. Solder the base of the transistor to IC201 pin 56 foil pad. Solder the collector and one end of the 10K resistor to the foil pads of jumper W2C4. The foil from the jumper (W2C4) pads connect to pin 17 of IC202. It will not be necessary to run a separate wire to pin 17. Solder the other end of the 10K resistor to +5 volts at jumper W2H5. Put an insulating sleeve on the emitter lead and then solder the emitter lead to pin 5 of IC201, which is ground. Place a piece of plastic electrical tape under the transistor. Carefully install the transistor as close to the PC board as possible, maintaining proper dress lead and safety. Refer to the diagram.
